**DEPARTMENT OF TRANSPORTATION**

Contract #: 04-0120F4Cty: SF/ALA Rte: 80 PM: 13.2/13.9File #: 1.28**WELDING INSPECTION REPORT****Resident Engineer:**Pursell, Gary**Address:** 333 Burma Road**City:** Oakland, CA 94607**Report No:** WIR-012992**Date Inspected:** 09-Apr-2010**Project Name:** SAS Superstructure**OSM Arrival Time:** 630**Prime Contractor:** American Bridge/Fluor Enterprises, a JV**OSM Departure Time:** 1500**Contractor:** American Bridge/Fluor Enterprises, a JV**Location:** Job Site**CWI Name:** Listed below.**CWI Present:** Yes No**Inspected CWI report:** Yes No N/A**Rod Oven in Use:** Yes No N/A**Electrode to specification:** Yes No N/A**Weld Procedures Followed:** Yes No N/A**Qualified Welders:** Yes No N/A**Verified Joint Fit-up:** Yes No N/A**Approved Drawings:** Yes No N/A**Approved WPS:** Yes No N/A**Delayed / Cancelled:** Yes No N/A**Bridge No:** 34-0006**Component:** Orthotropic Box Girders (OBG)**Summary of Items Observed:**

- 1) OBG Lifts 1W/2W - plate E field splice welding
- 2) OBG Lifts 1E/2E - plate E field splice weld repairs

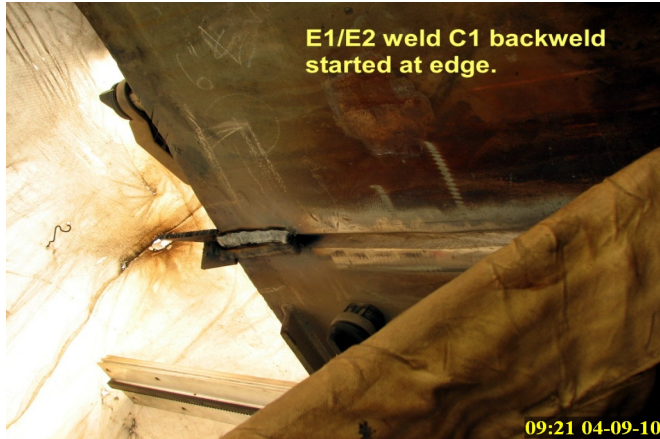
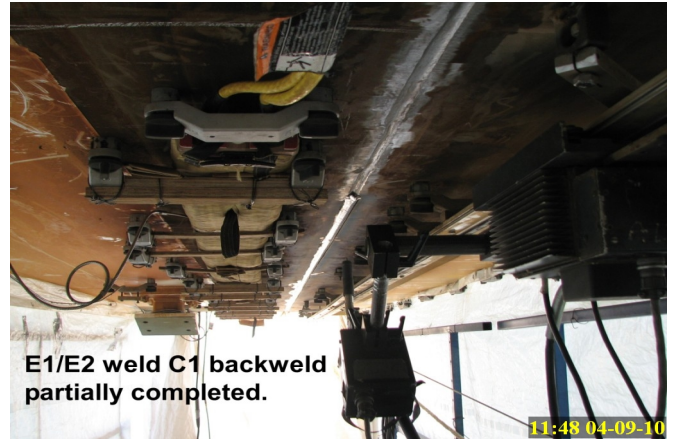
2) The QAI observed ABF personnel back welding plate C at OBG Lifts 1E/2E field splice. The QAI noted that the overhead position (4G) complete joint penetration (CJP) weld segments C1 and C2 are being completed after the backing bar has been removed. The QAI noted that the Quality Control (QC) Inspector Jim Cunningham is monitoring this welding. The QAI observed ABF personnel Jeremy Dolman, ID 5042 and Rory Hogan, ID 3186,

making the welds with gas shielded flux cored arc welding (FCAW-G). At the start of the shift, the QAI made general observations of the back gouged groove and noted that it was ground to bright clean metal. See the attached photo. The QAI was informed that ABF-WPS-D15-3040A-1 is being used for this welding. As the welding commenced, the QAI randomly measured the preheat, interpass temperature and welding parameters and noted that they appeared to be conforming to the WPS requirements. This welding was in progress at the end of the QAI's shift. See the attached photo.
